# Gariwerd assessment update

# PROJECT 4 RESULTS (LOCATIONS & IMPACTS)

# PROJECT 1 RESULTS (OBSERVED IMPACTS)

## PROJECT 2 RESULTS (OBSERVED IMPACTS - SPA 1: FLAT ROCK 4)

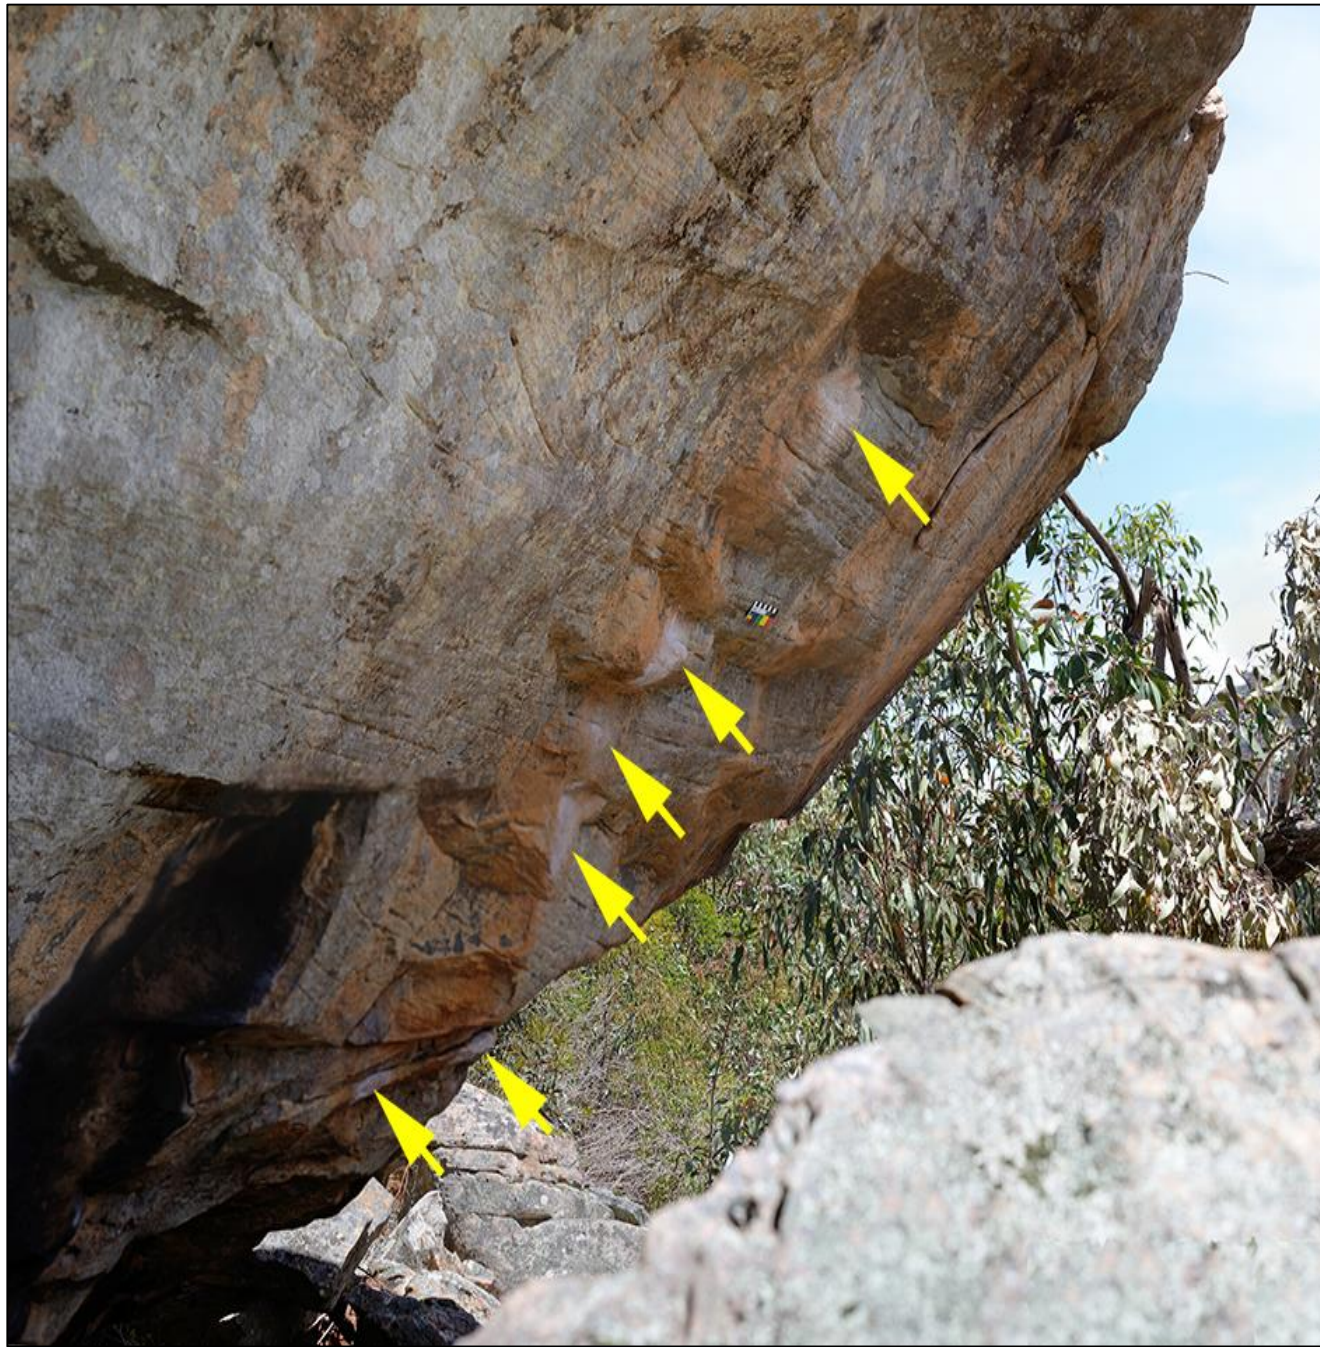
Column of chalk marks within the shelter of the Flat Rock art site. The chalk build up is dense suggesting repeated climbing.

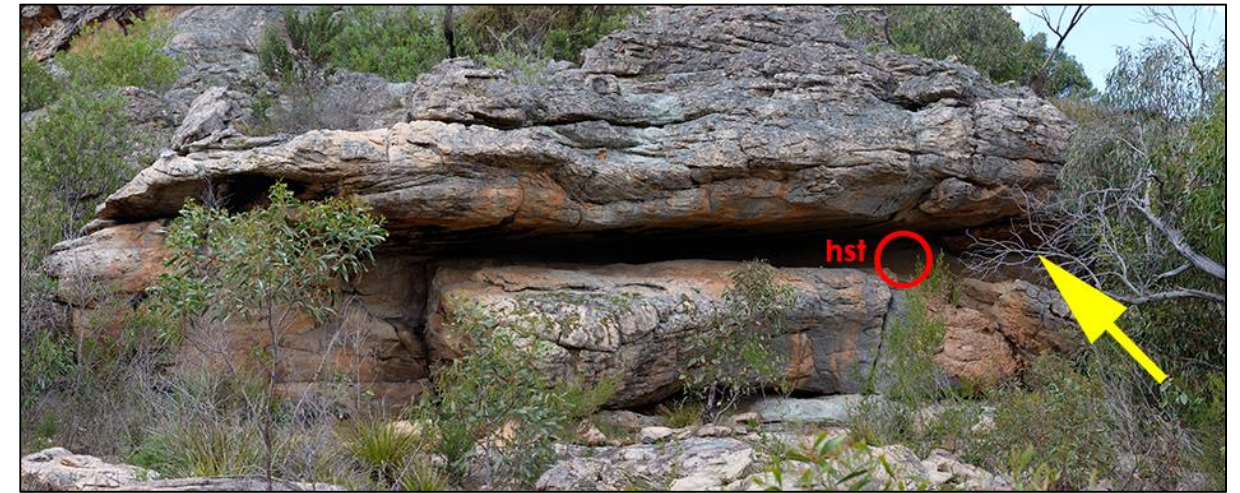
There is a chalked area is 3.5m west of the closest hand stencil.

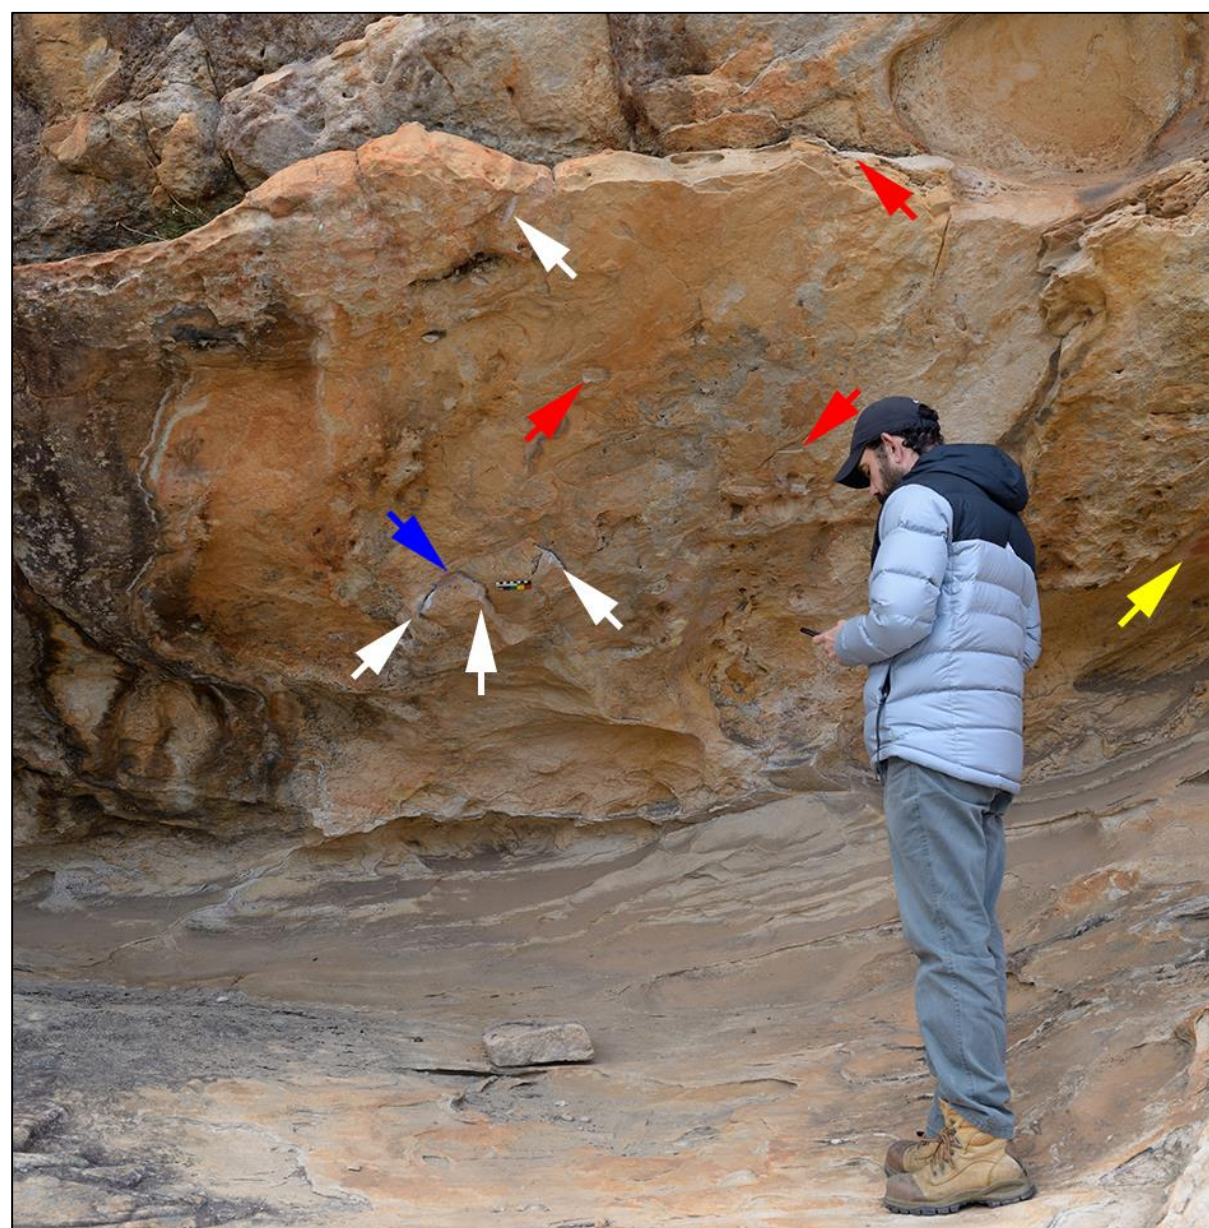
White = chalk, Red = recent rock breaks, Blue = adhesive  
Yellow = location of hand stencil

The shelter has suffered serious damage as a result of bouldering. Four instances of bouldering chalk were located in the art shelter (1.8m east of the art). Four rock breaks consistent with bouldering damage were also present within the shelter. A cement-like material appears to have been applied in conjunction with the chalk.

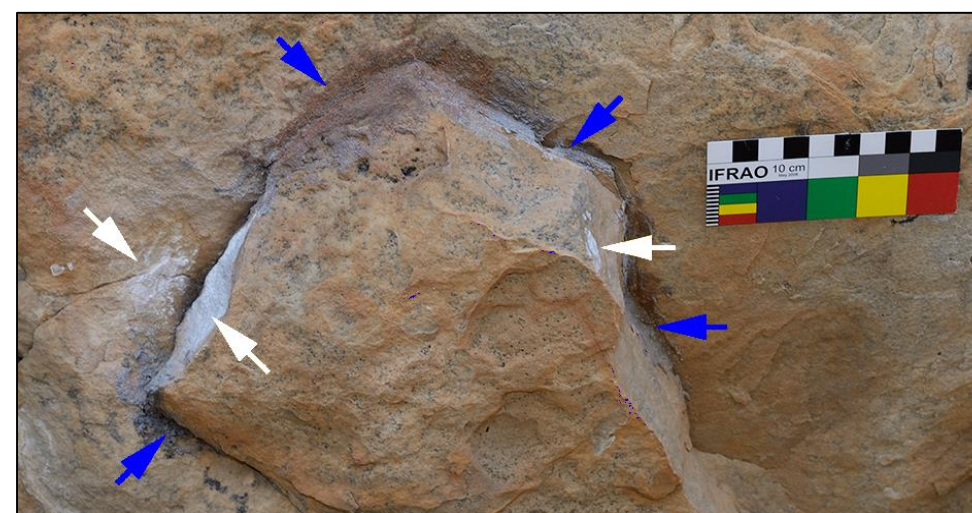
Chalk marks (white) and adhesive remnants (blue)

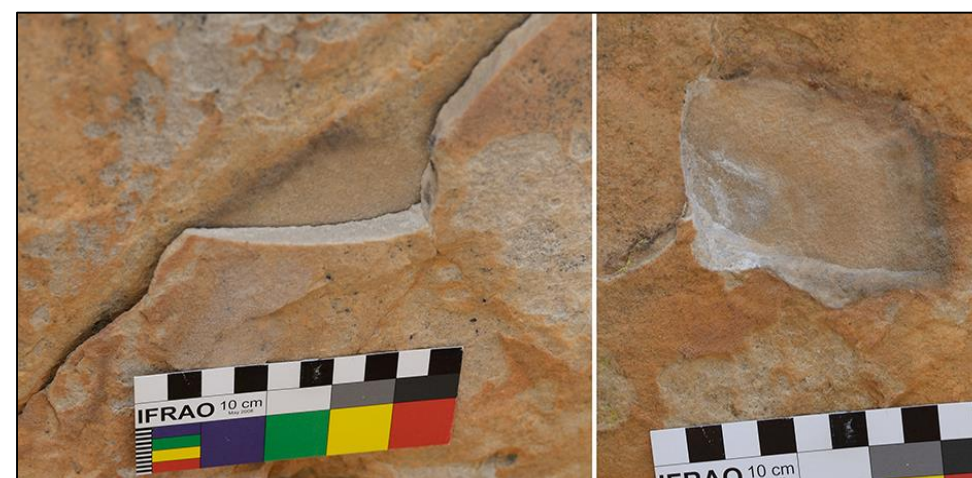
Two examples of recent rock damage

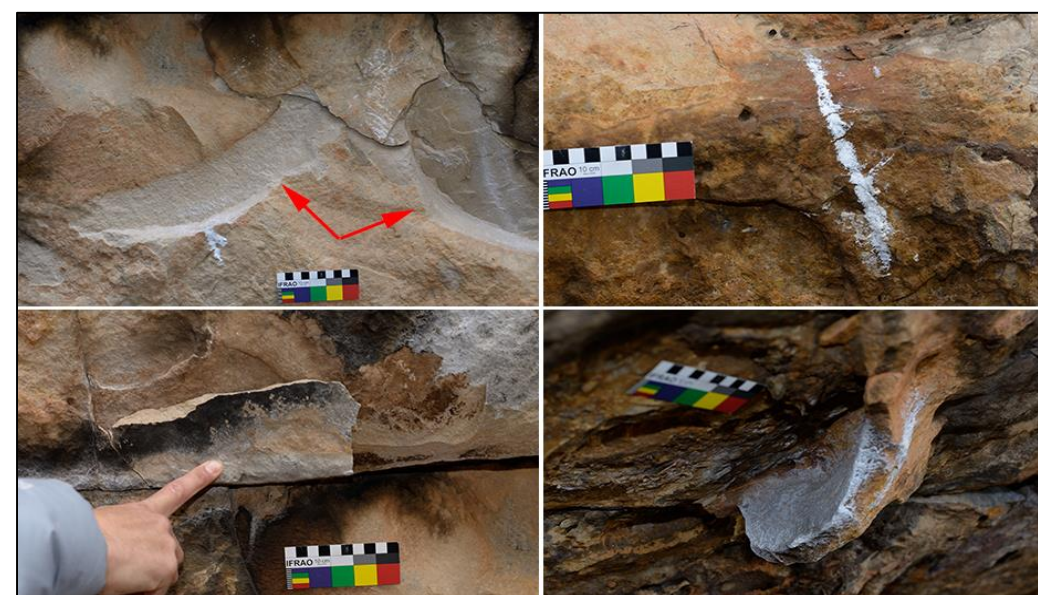
Further chalking evident in three adjacent rock shelters all located within 50 metres (and within the SPA).

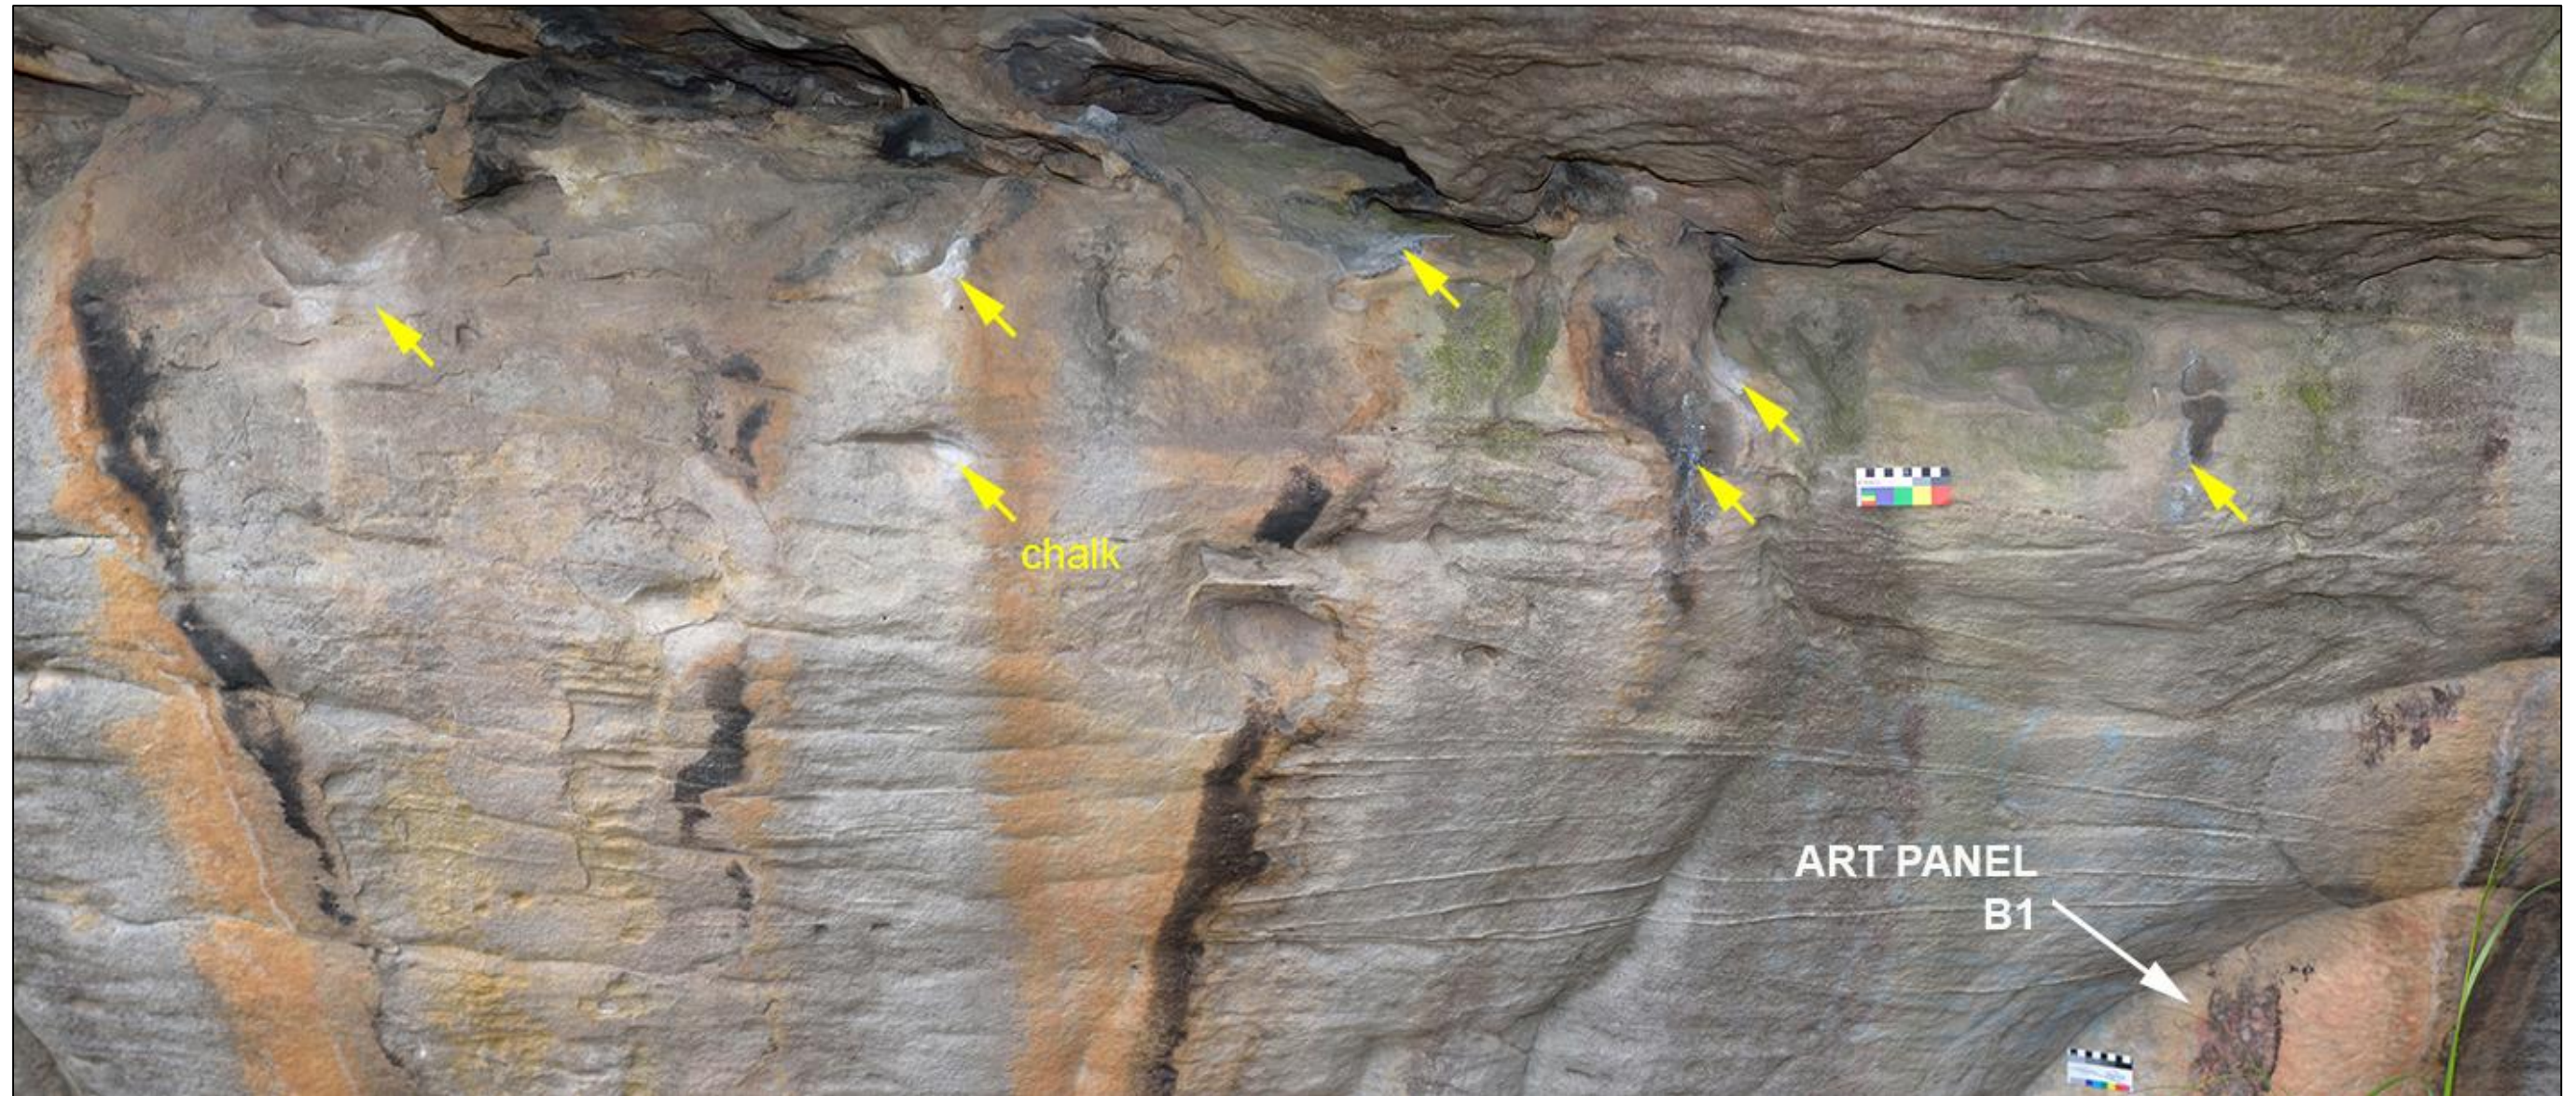
Seven instances of bouldering chalk detected along a horizontal ledge above the art panel

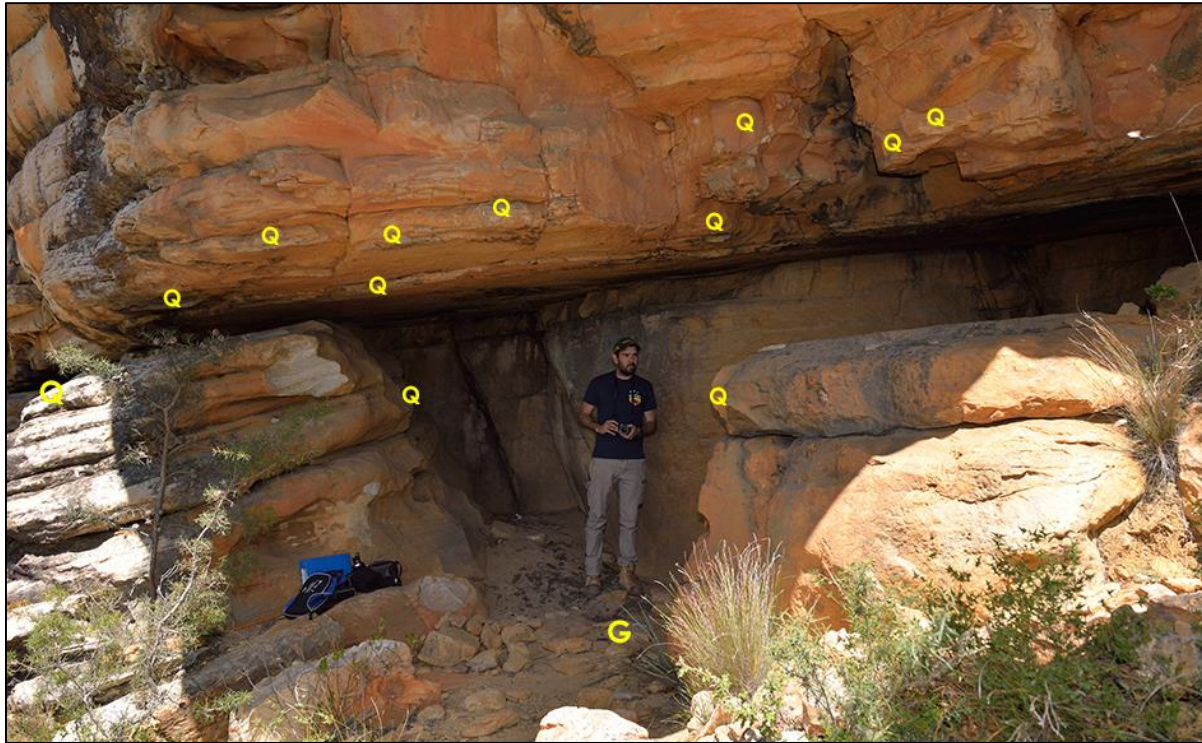
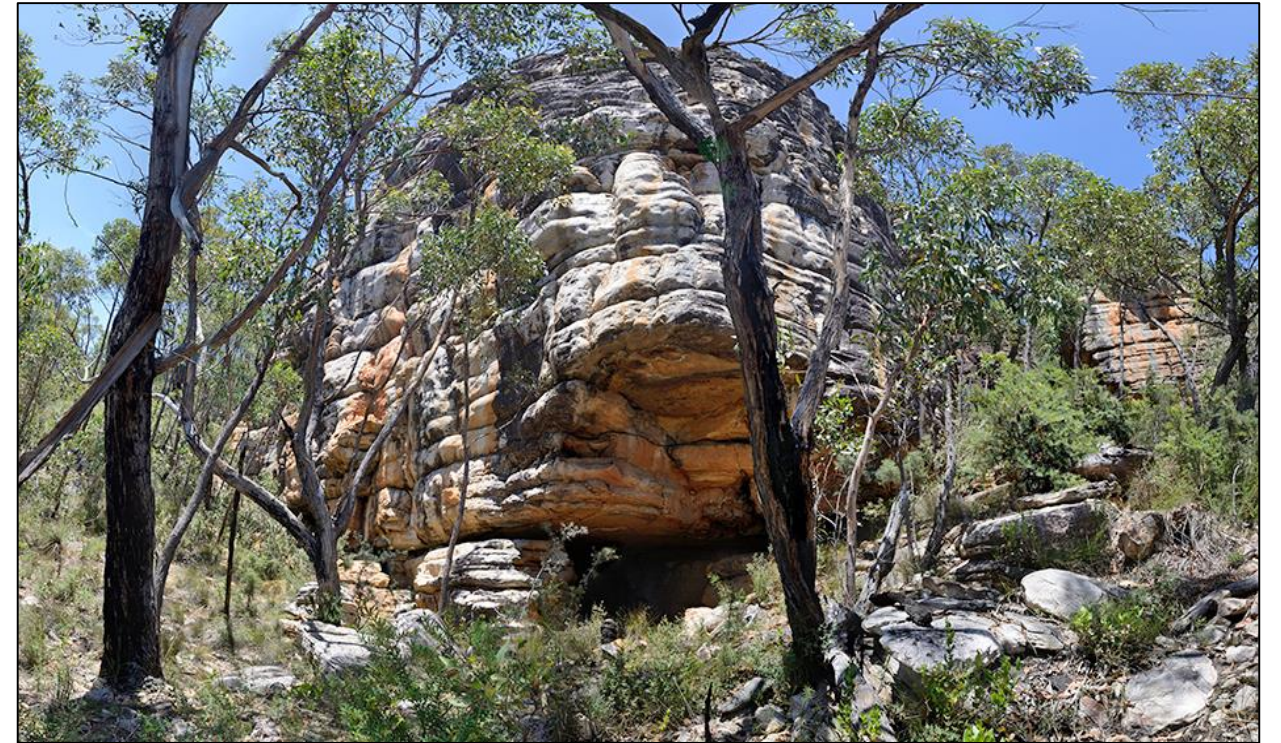
Gilham's Shelter does not contain rock art.

It is, however, a more significant archaeological site than was originally recorded as it has extensive quarrying throughout the shelter and around and along the northern cliff wall. The shelter also contains an Aboriginal grindstone and a surface scatter indicating that the site was an Aboriginal occupation shelter.

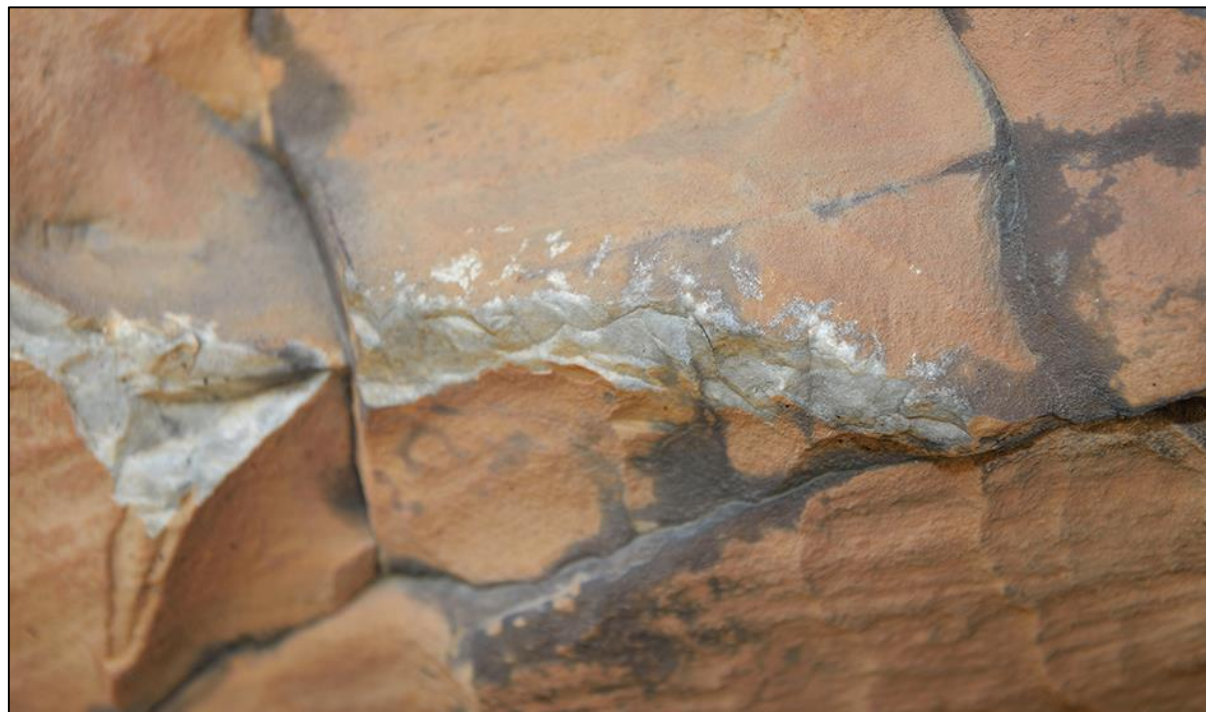
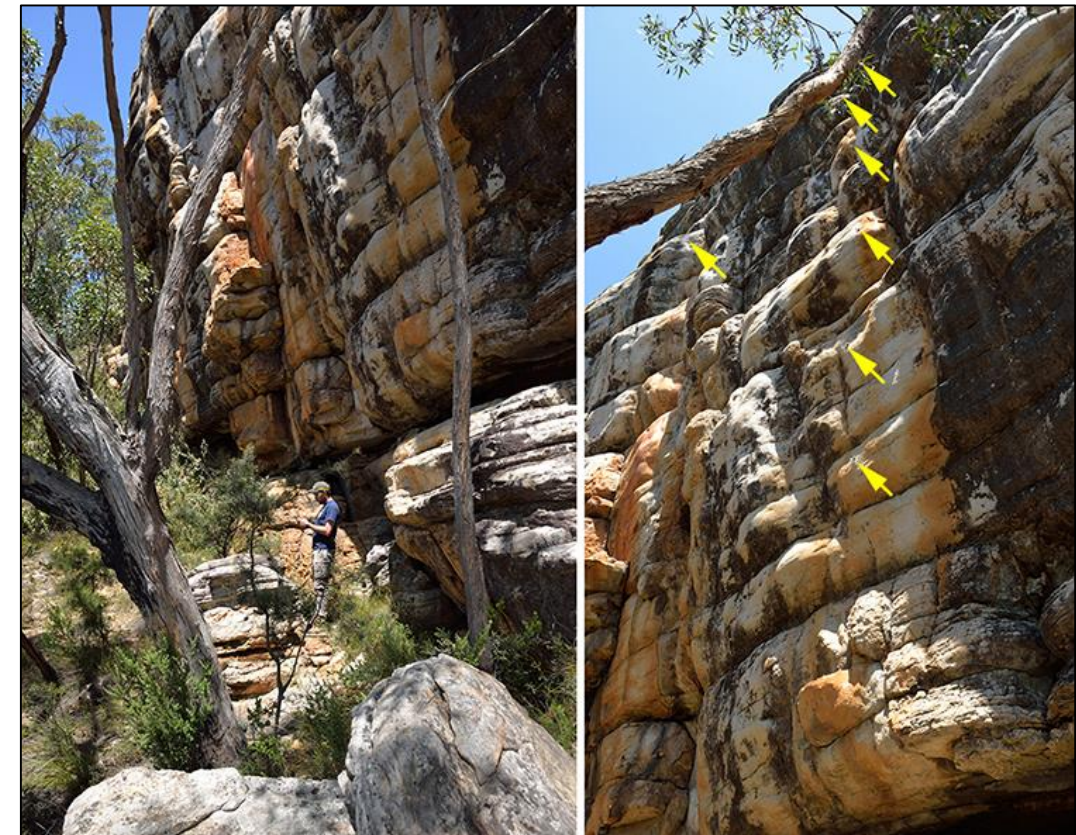
Gilham's shelter exterior wall showing location of visible climbing bolts

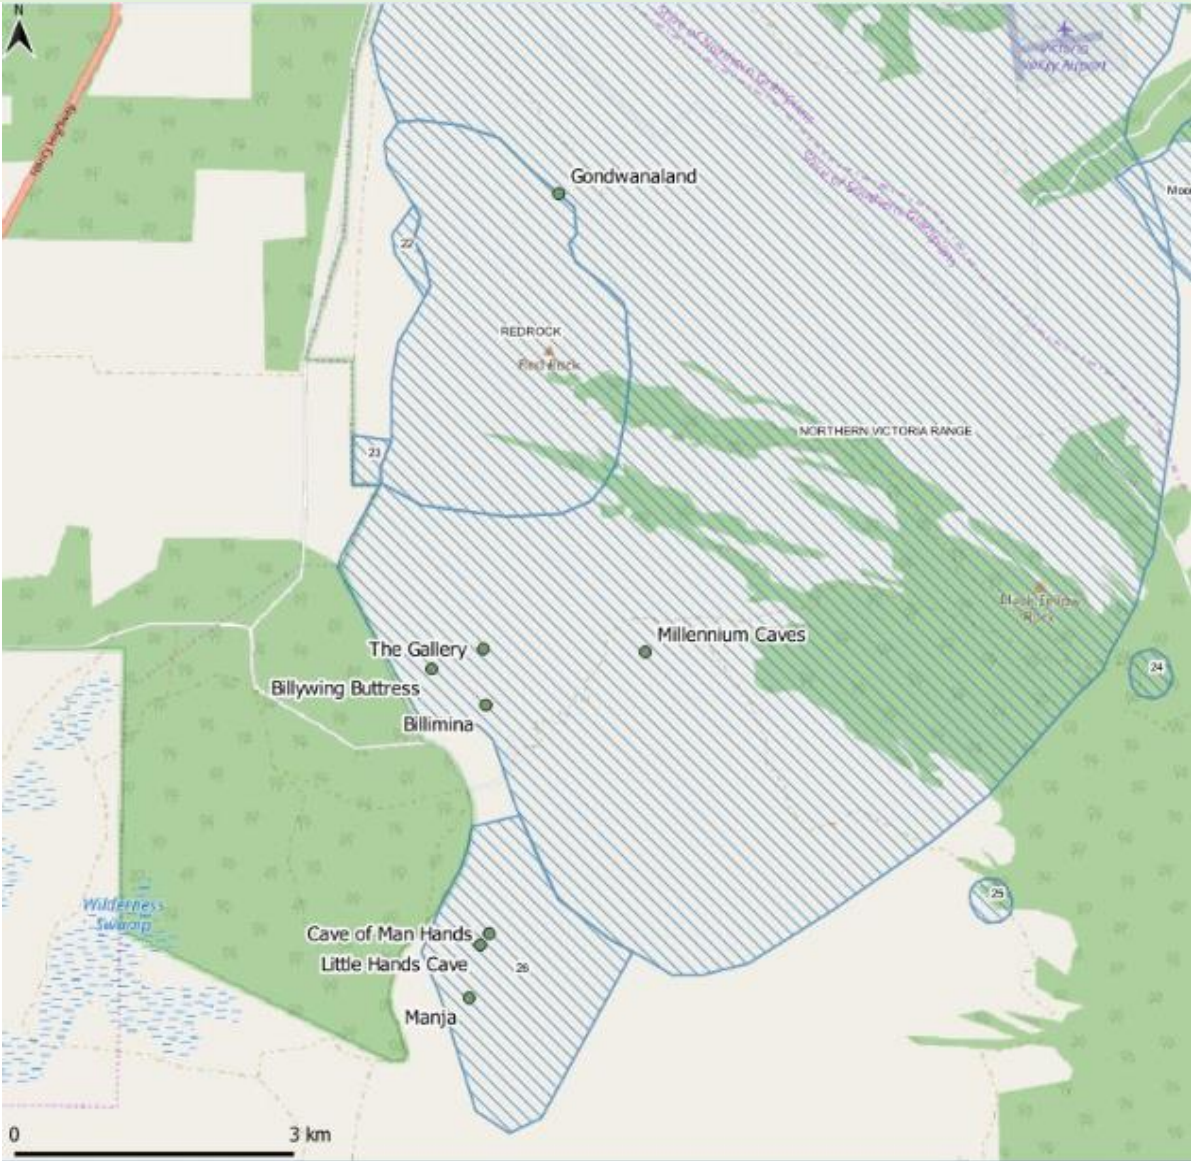
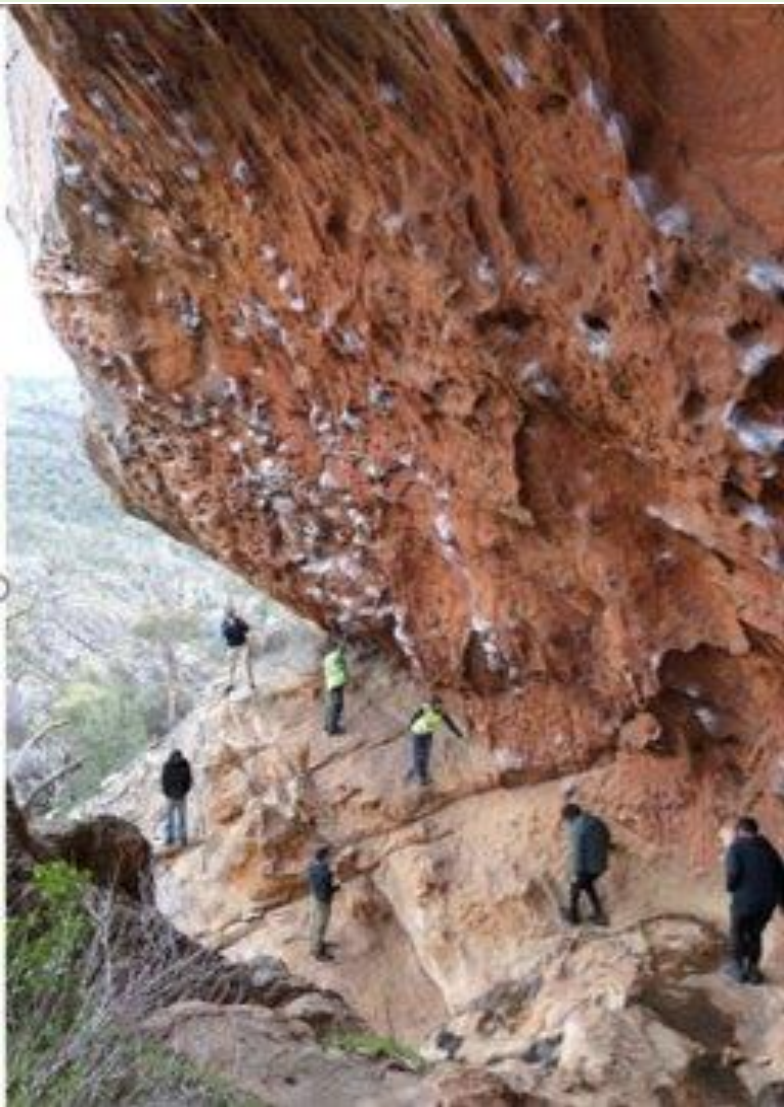
Chalk marks within the Gallery shelter – a registered stone quarry site
